# **XLINKS MORROCO-UK POWER PROJECT**

## **Preliminary Environmental Information Report**

**Volume 2, Appendix 1.5: Preliminary Ground Level Bat Tree Roost Assessment**

**Preliminary Ground Level Bat Tree Roost Assessment**

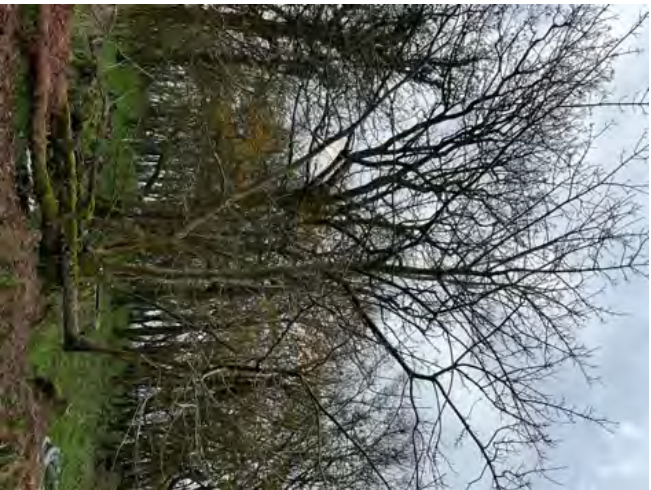
3.4 A total of five sycamore trees were classified as having '*Moderate*' potential, of which T1 had a pair of tear-outs, one extending upwards with the other healed over (Table 1). Sycamores T16, T17, T19 and T21 all had wounds, some of which extended, with a central union noted on T16 and several knotholes on T17, of which one extended to an open cavity.

T1 – Sycamore (Moderate)

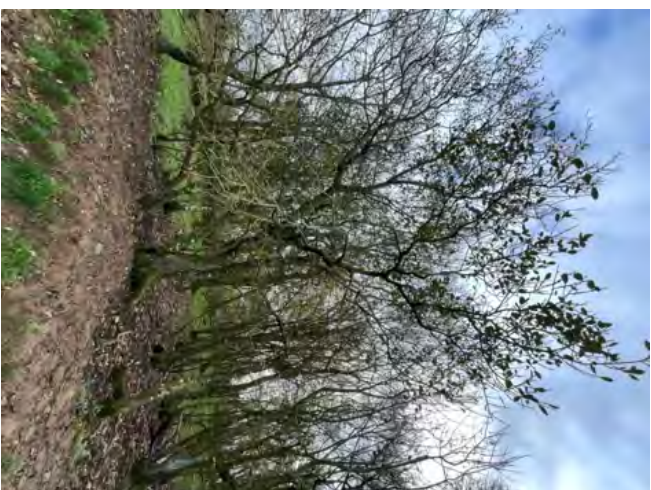
T2 – Willow (Moderate)

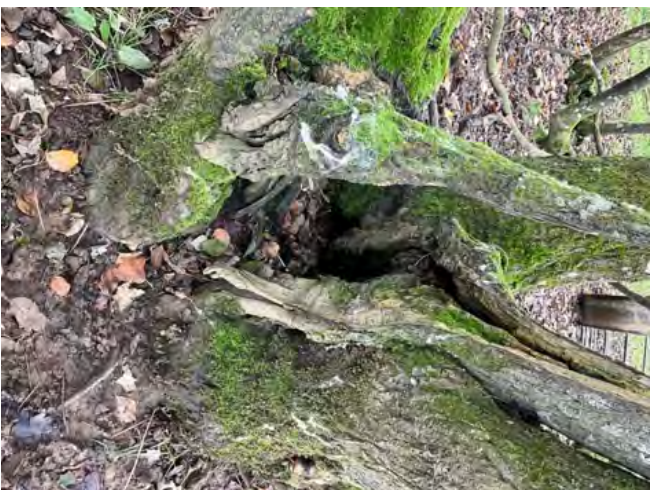
3.2 Of the trees classified as having '*Moderate*' potential, two were willow sp. (Table 1). Tree 2 (T2) contained a butt-rot that did not extend, although with a wound on the stem that may extend. Tree 6 (T6) contained two wounds, one of which was healed over and the other potentially extending, as well as occasional snap-limbs throughout.

T2 – Butt-rot with wound above

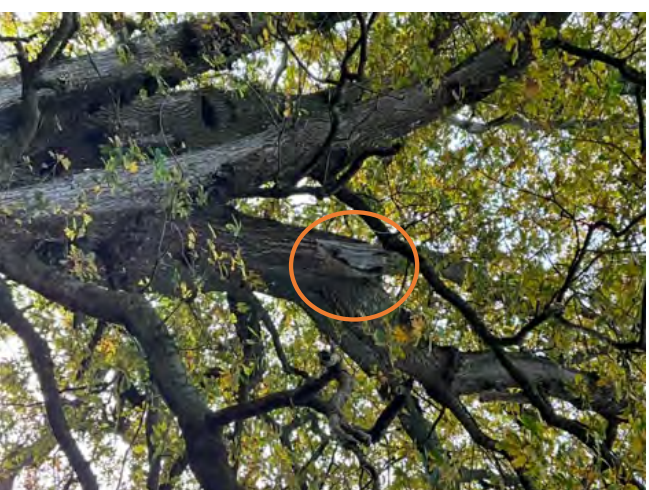
T3 – Tear-out, likely extending

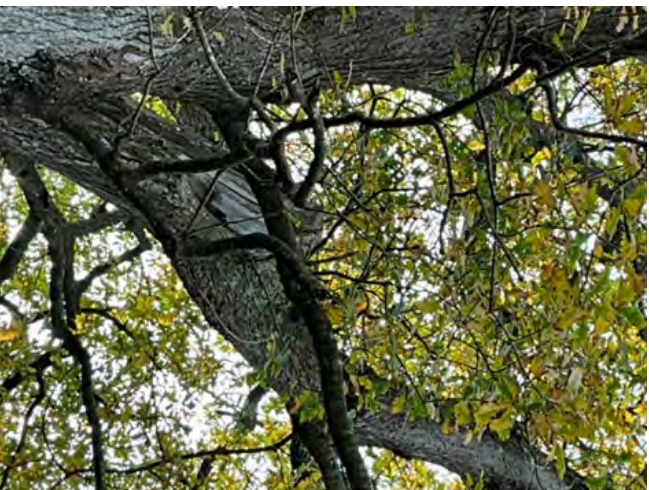
3.8 All four trees considered to have '*High*' potential to support roosting bats were oak trees. The first (T3) had knotholes, stags with collars and ivy throughout, as well as a flush-cut that had fissures, a woodpecker hole, and a tear-out with a likely extending cavity. The second (T5), had stags and ivy throughout, the latter of which formed plates in places. In addition, T5 had a number of tear-out and knotholes that may extend. The third oak (T11) had a tear-

T3 – Flush-cut with fissures

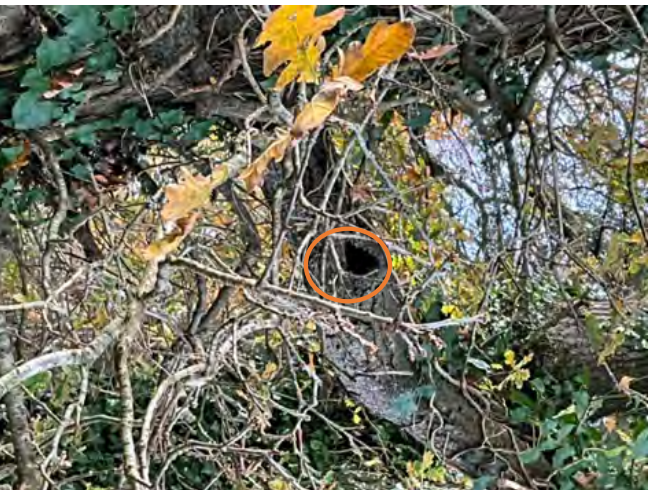
T4 – Knothole

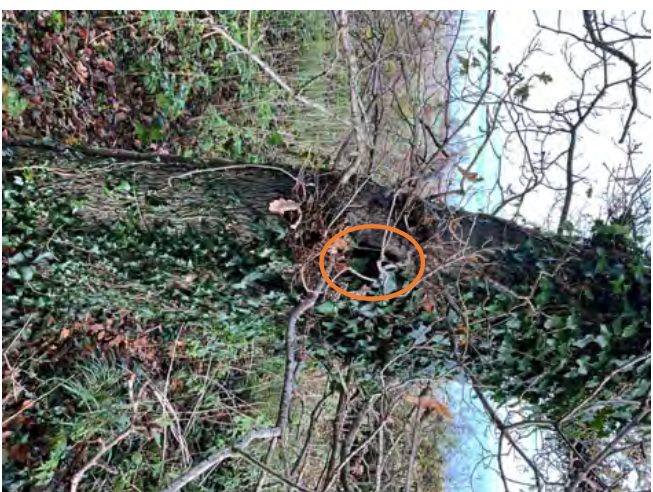
T4 – Knothole

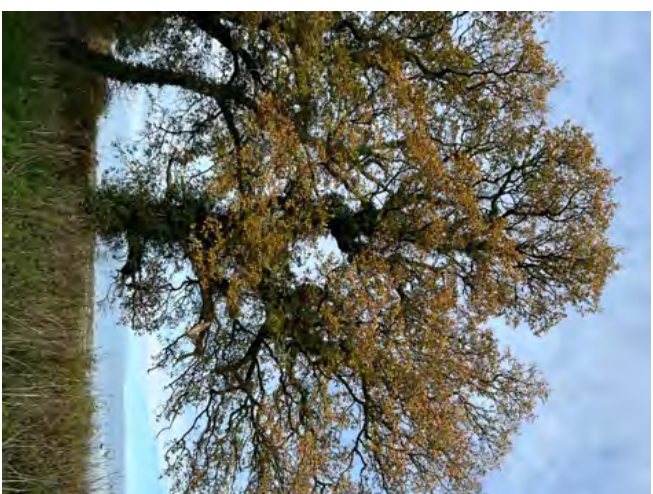
T5 – Oak (High)

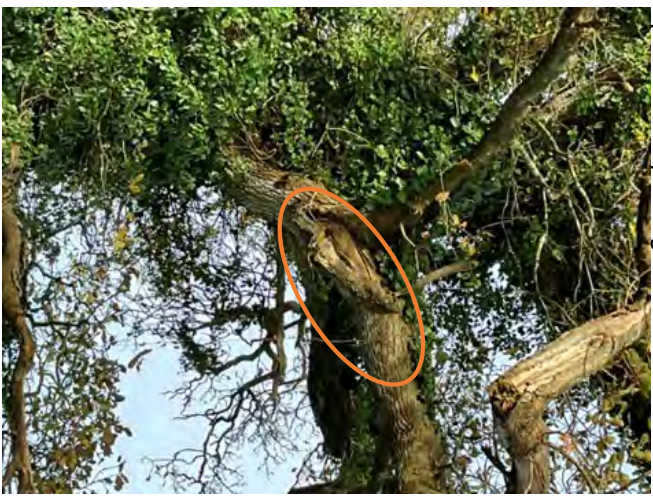
T5 – Tear-out and ivy, > 50 mm in places with plaiting

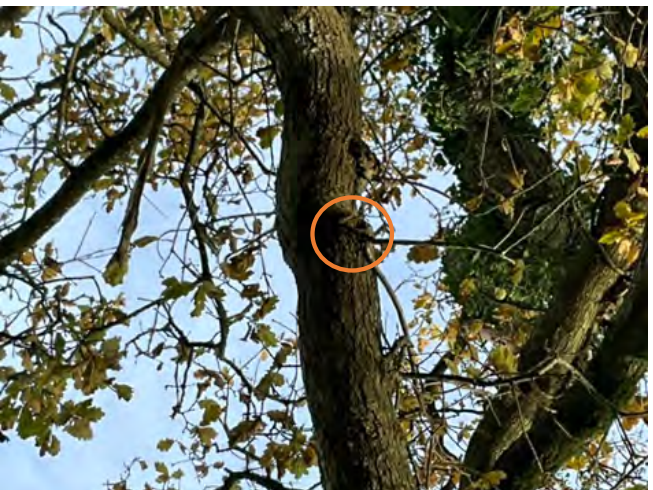
T5 - Knothole

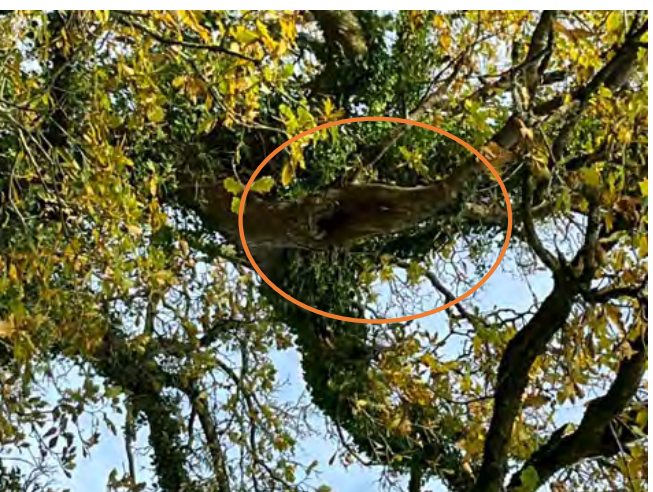
T5 – Tear-out/knothole

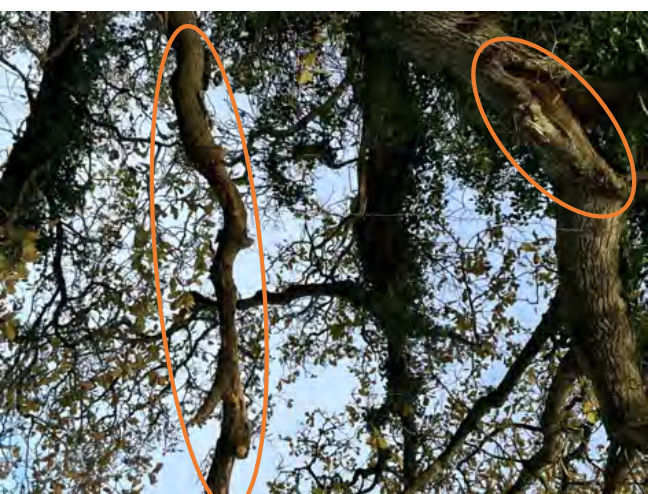
T5 – Tear-out and stag

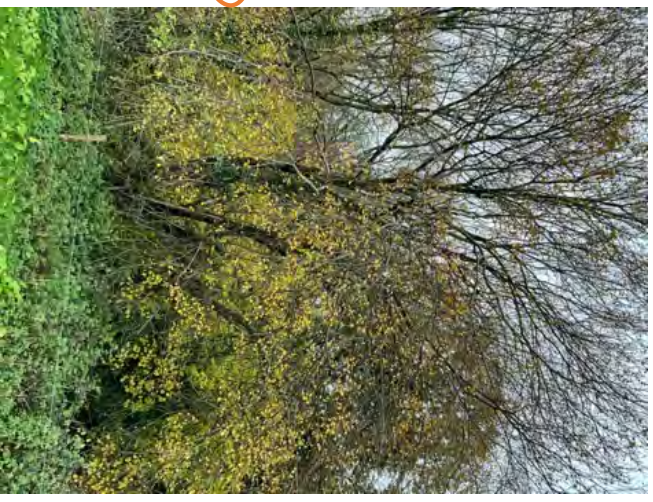
T6 – Willow (Moderate)

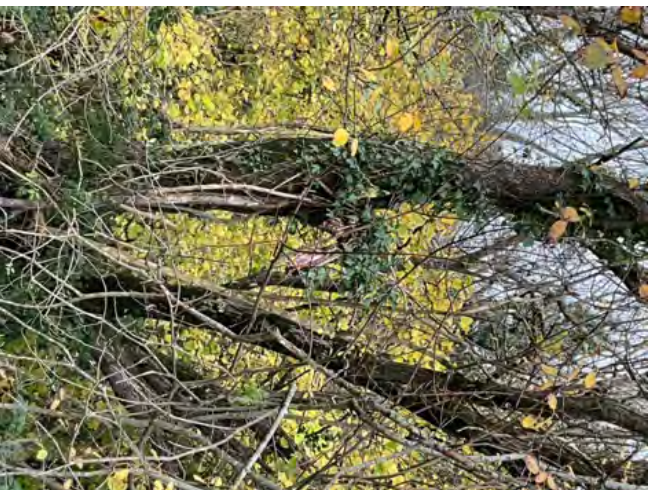
T6 – Snap-limbs throughout

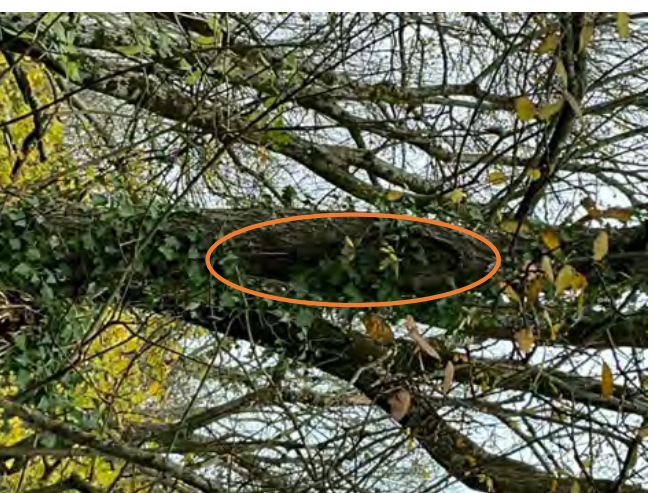
T6 – Wound

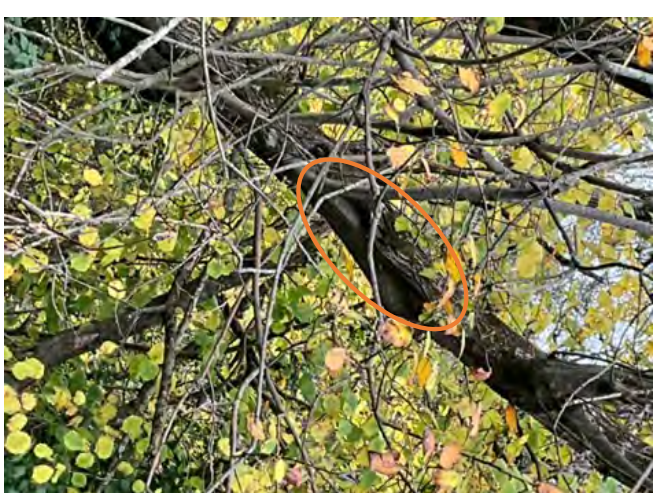
T6 – Wound, healed over

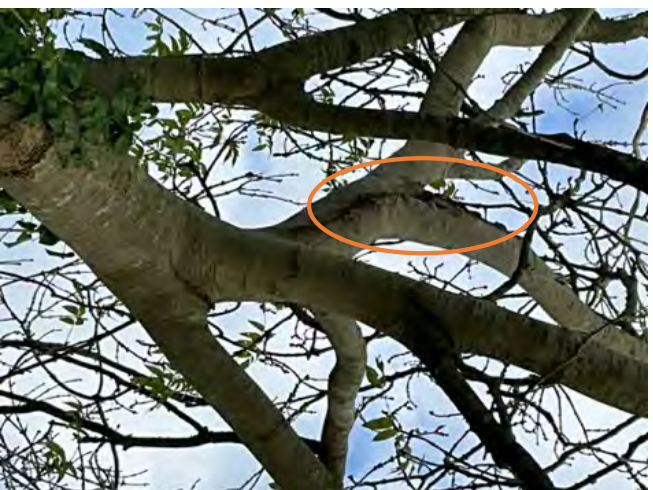
T7 – Tear-out

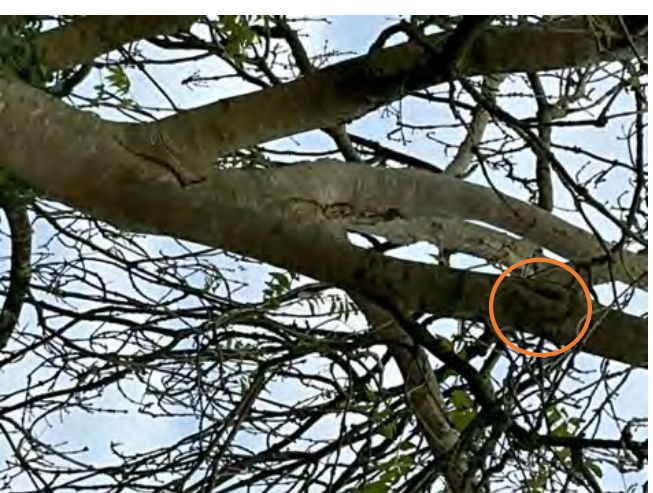
T7 – Canker wound

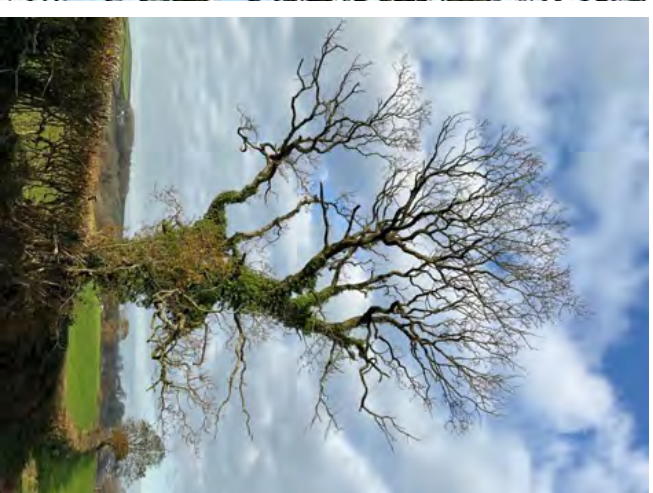
T8 – Oak (Moderate)

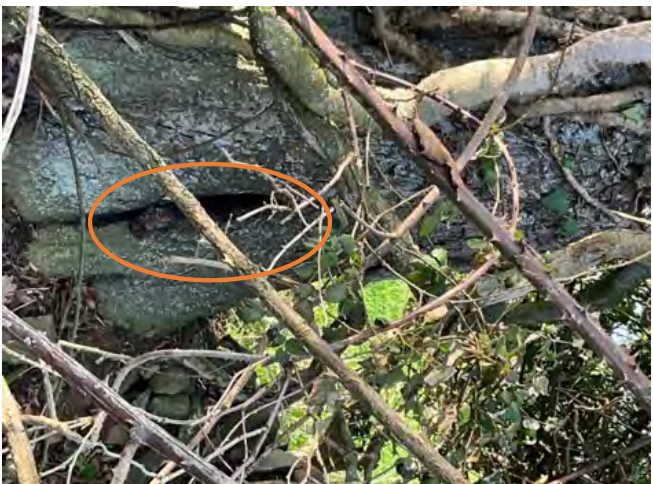
T6 – Butt-rot

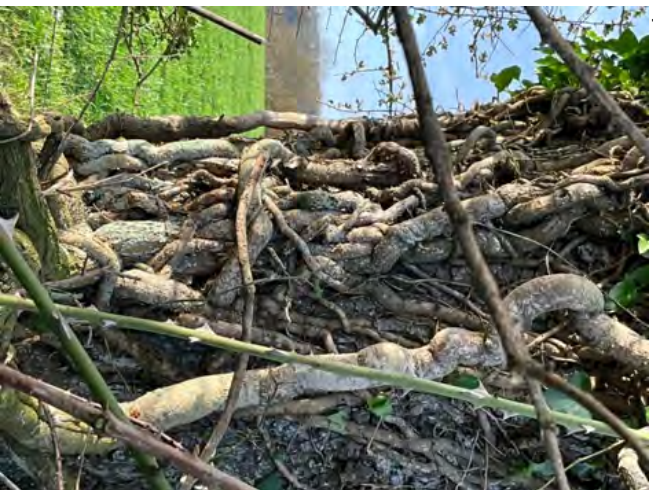
T8 – Ivy, > 50 mm with plaiting in places

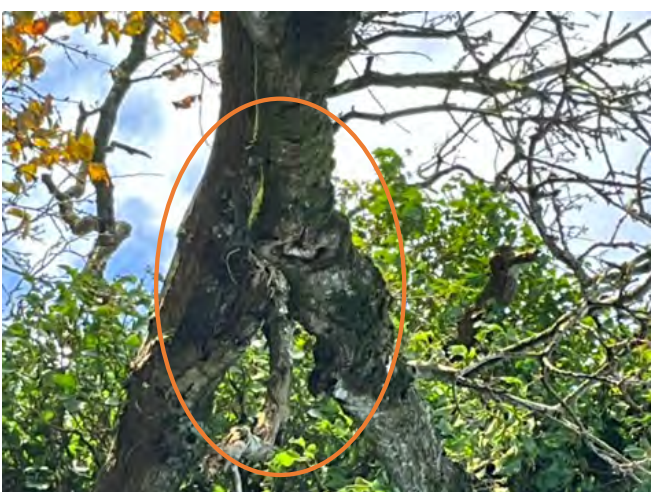
T8 – Snap-limb

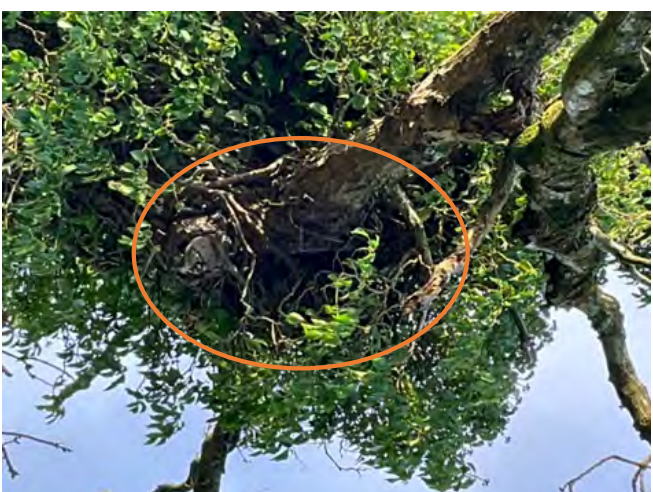
T8 – Tear-out that may extend

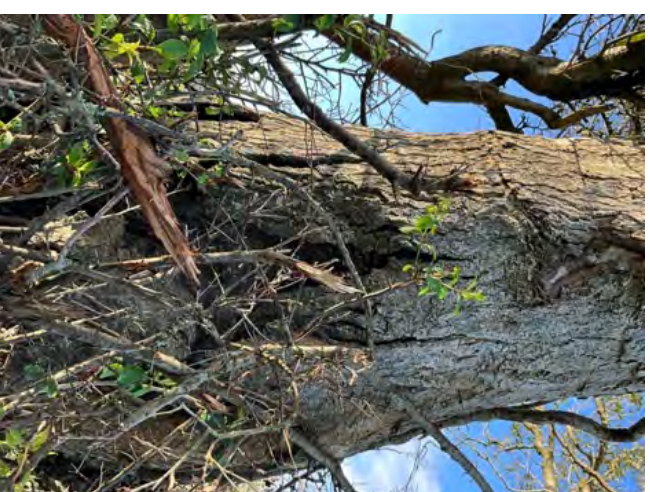
T9 – Wound, may extend

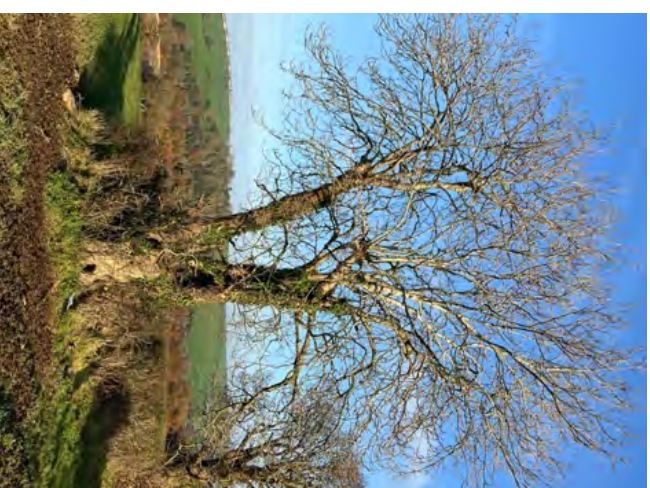
T10 – Ash (Moderate)

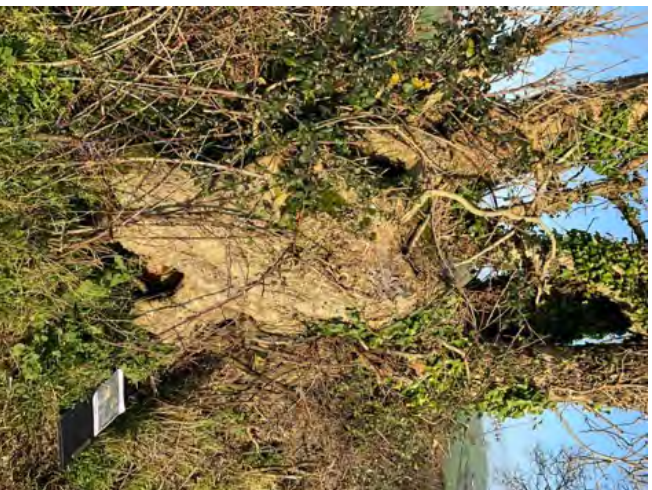
T10 – Butt-rot, multi-access, may extend into limbs

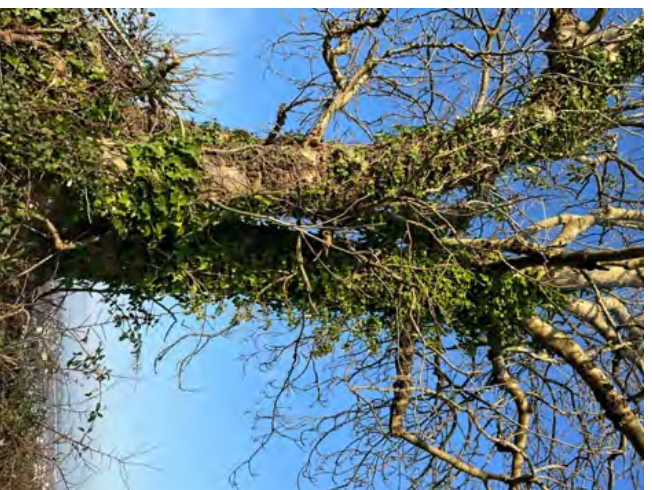
T10 – Ivy throughout, < 50 mm and no plating

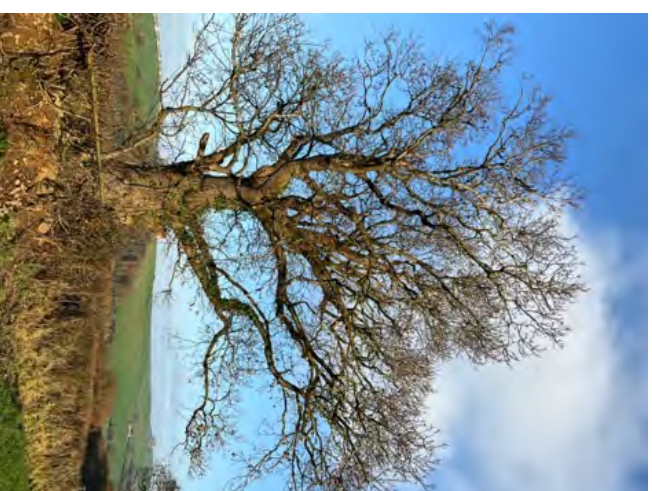
T11 – Oak (High)

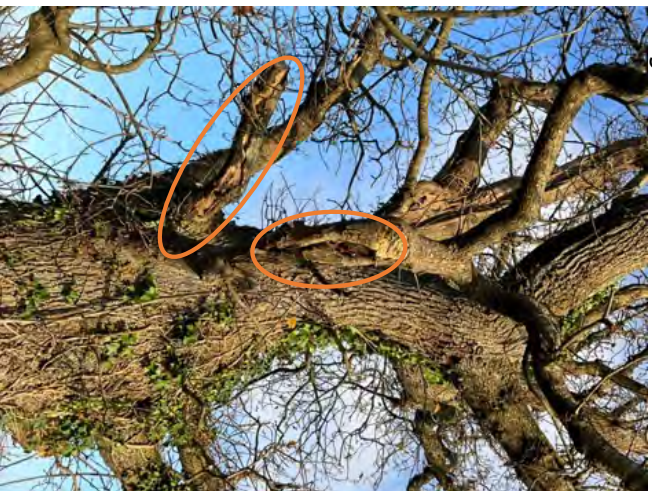
T11 – Wound that may extend and stags

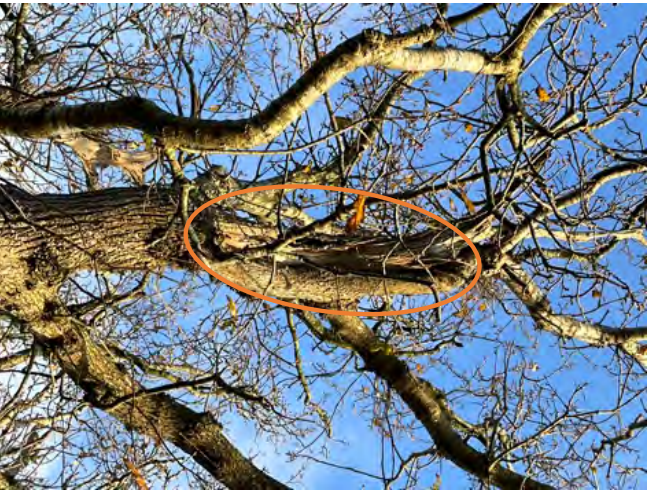
T11 – Tear-out, not extending

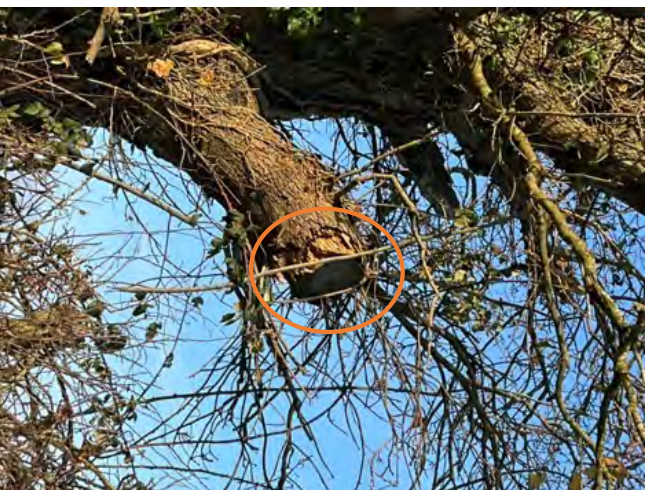
T11 – Flush-cut with no visible cavities

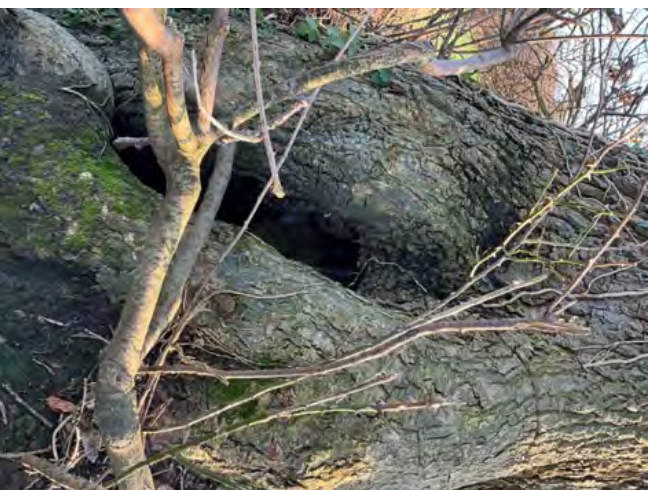
T11 – Butt-rot, may extend

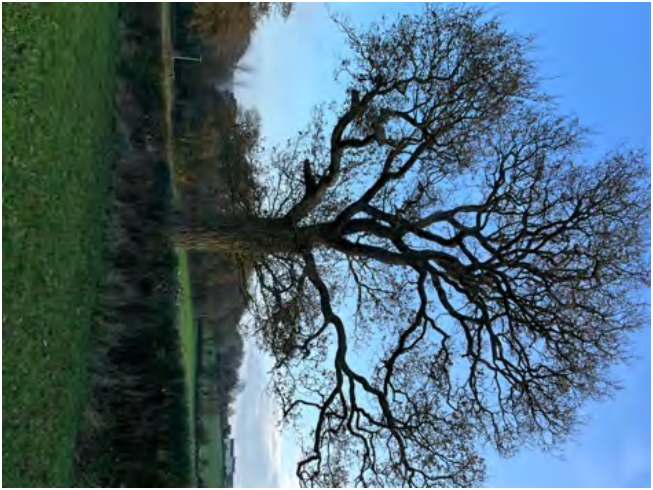
T12 – Oak (Moderate)

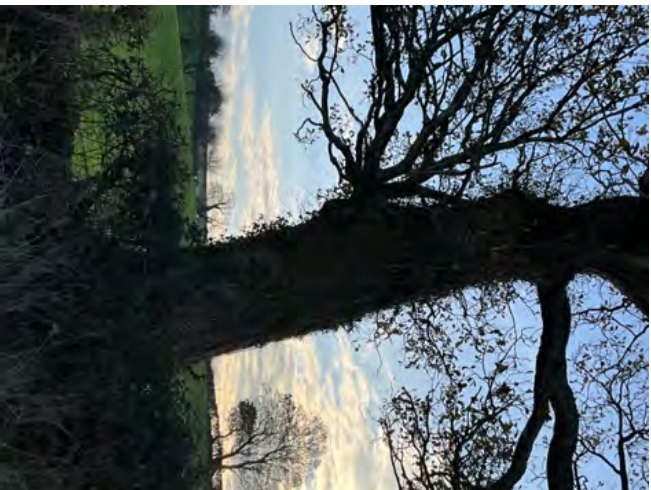
T12 – Ivy throughout, < 50 mm and no plaiting

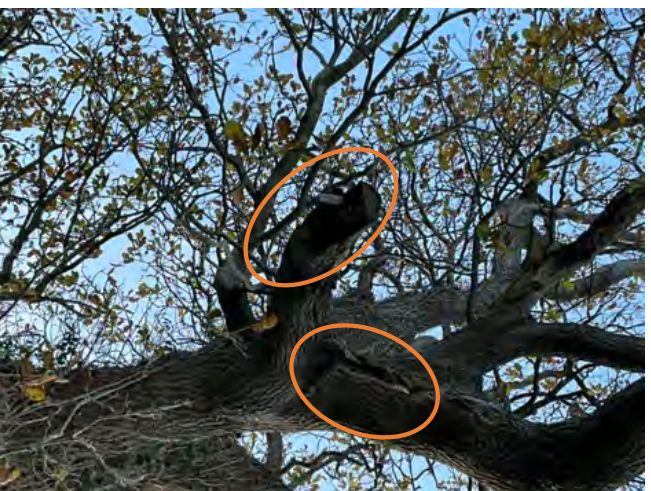
T12 – Flush-cut, rotten underneath and wound, healed over

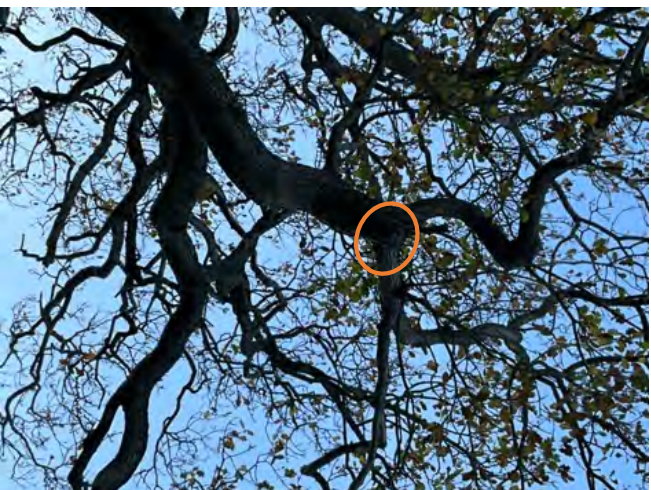
T12 – Flush-cut

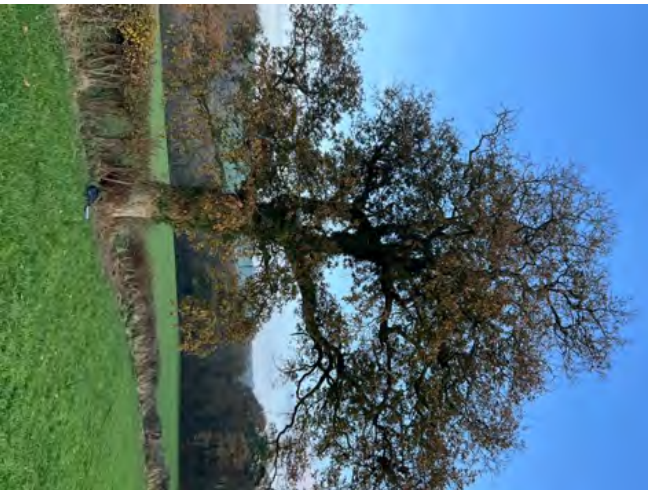
T13 – Oak (Moderate)

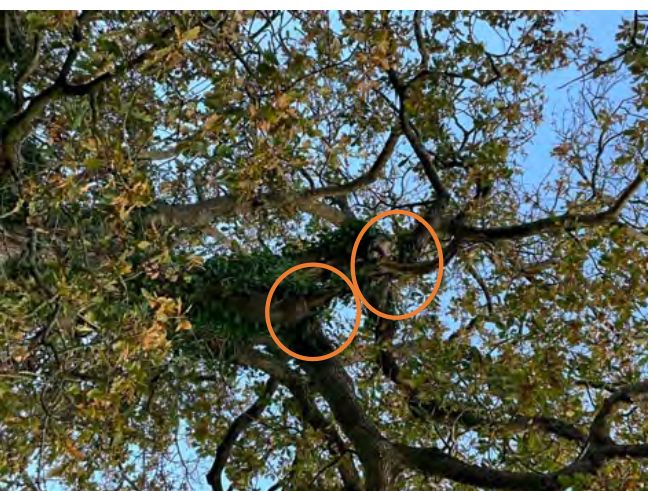
T13 – Stags, and knotholes, some extending with fissures

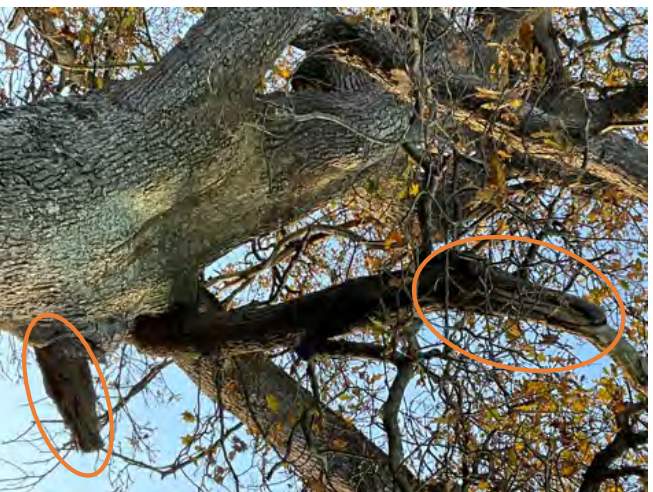
T14 – Lifting bark and stags

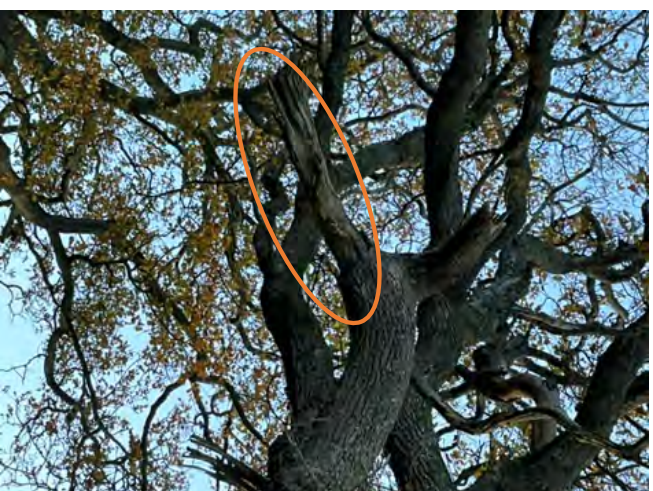
T14 – Stag with fissure

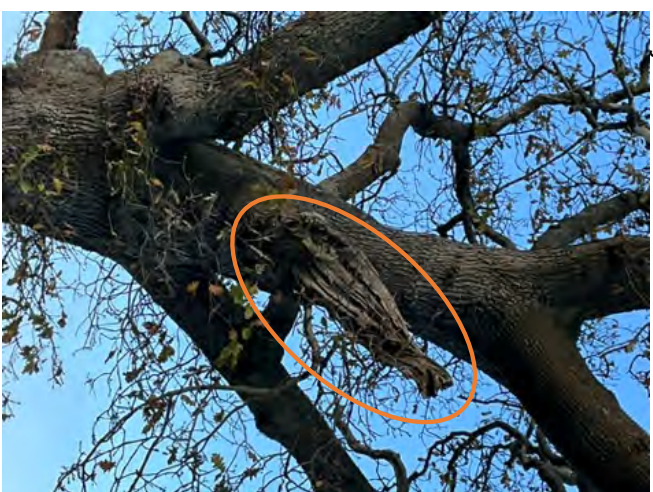
T12 – Snap-limb with a cavity that may extend

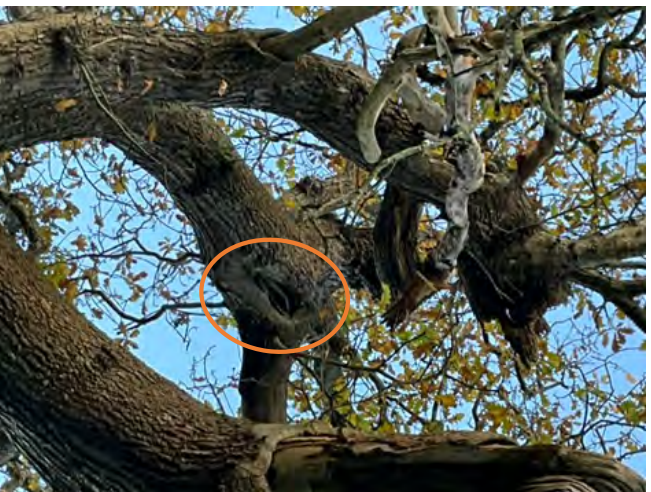
T14 – Tear-out with a likely extending cavity

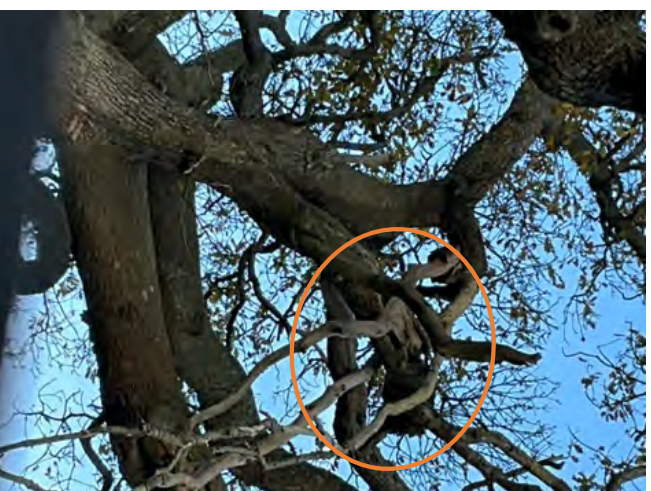
T14 – Snap-limb with upward cavity

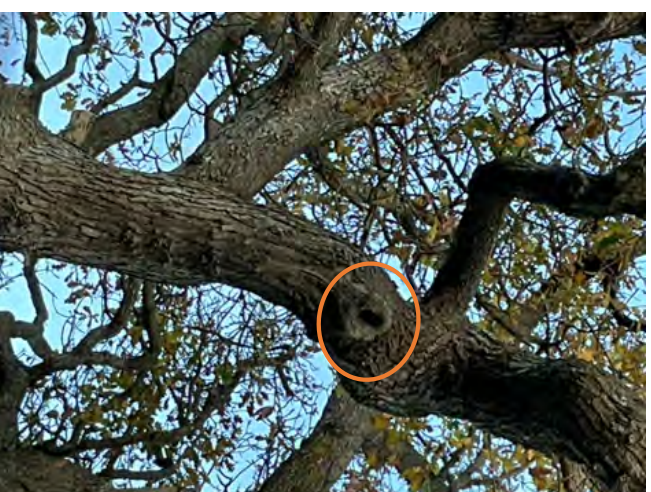
T14 – Knot-hole

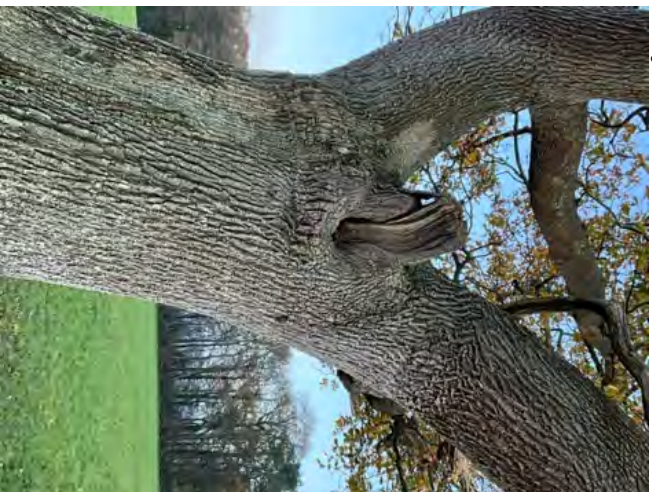
T15 – Knothole with part of stag that may extend

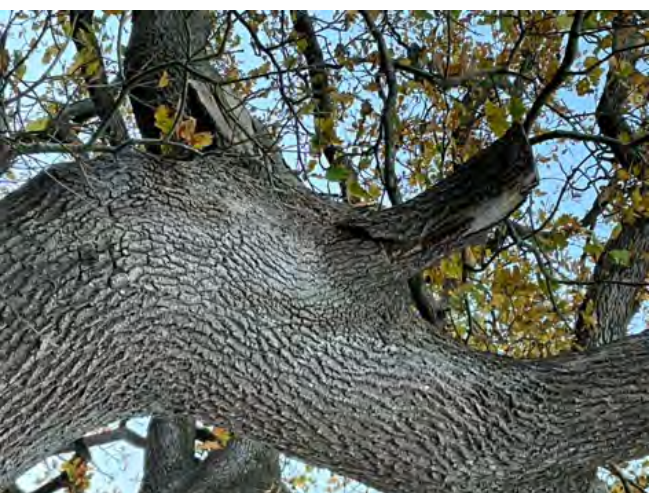
T15 – Flush-cut with lifting bark that may have extending cavity

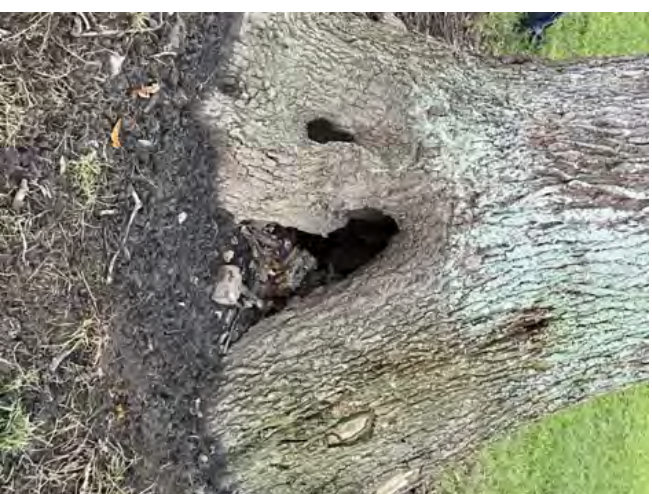
T15 – Butt-rot with extending cavity

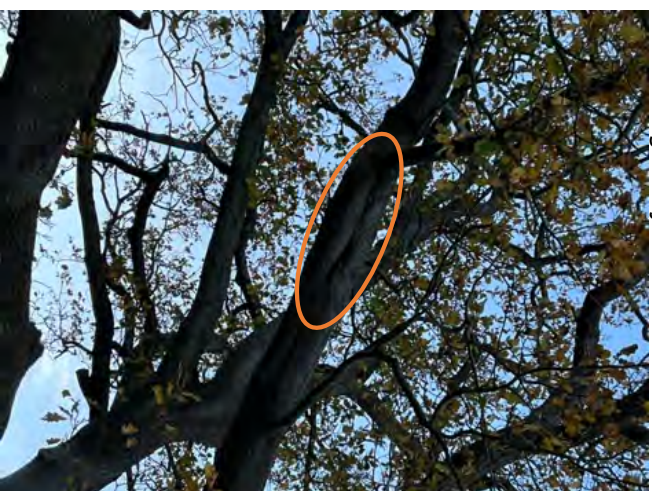
T15 – Wound that may have extending cavity

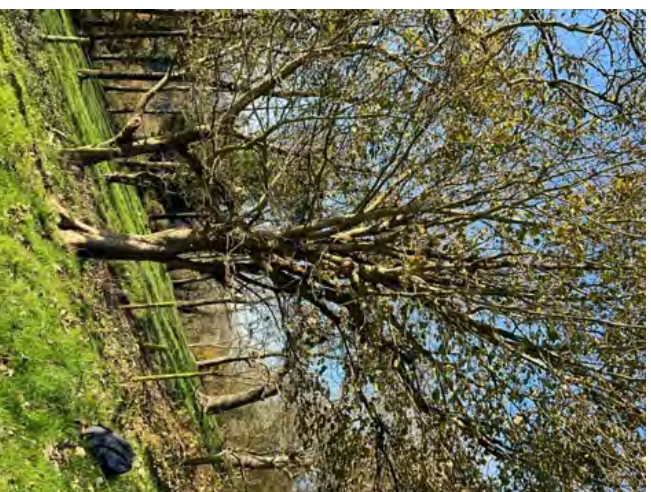
T16 – Sycamore (Moderate)

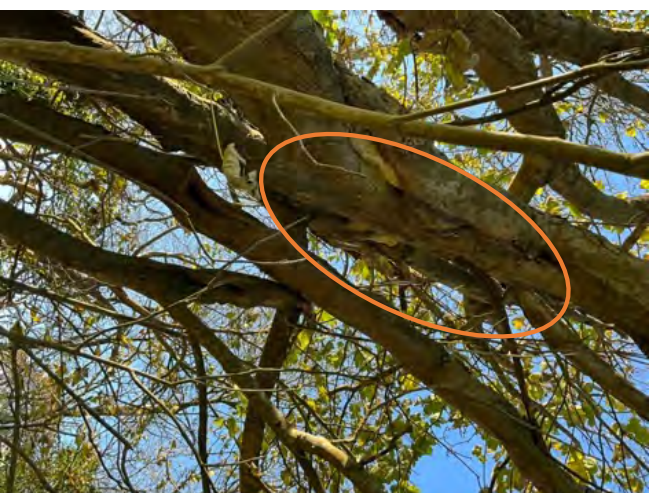
T16 – Union without extending cavity

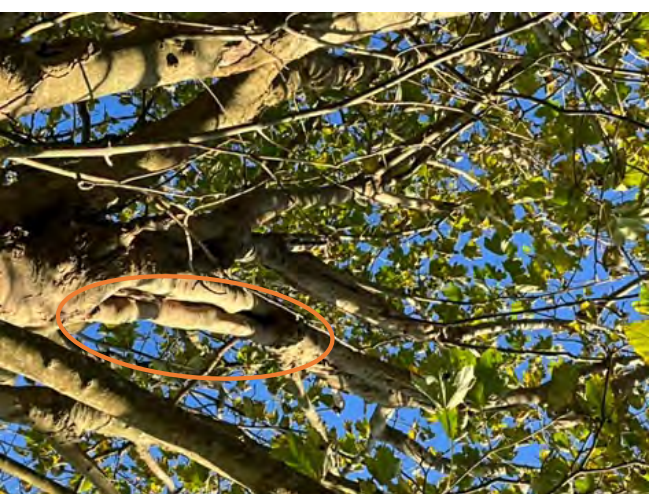
T16 – Wound that may extend

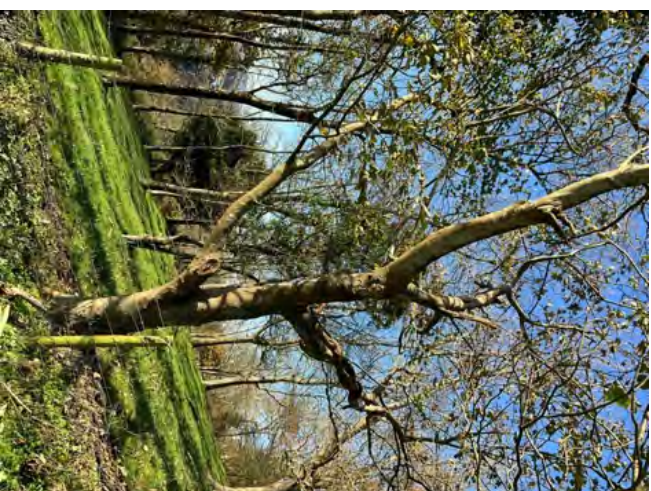
T17 – Sycamore (Moderate)

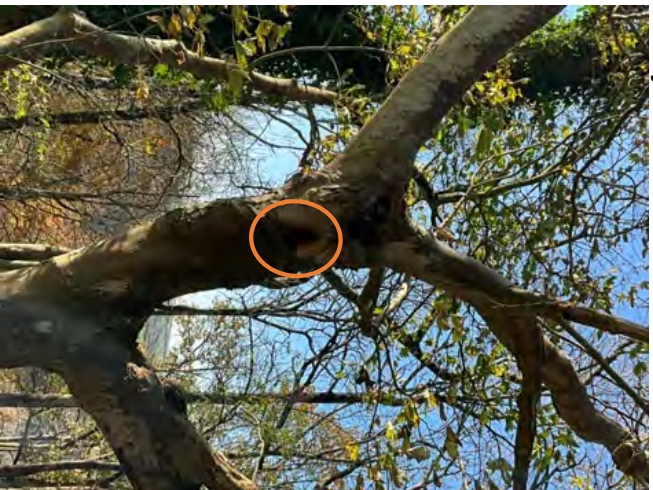
T17 – Knothole that extends to open cavity

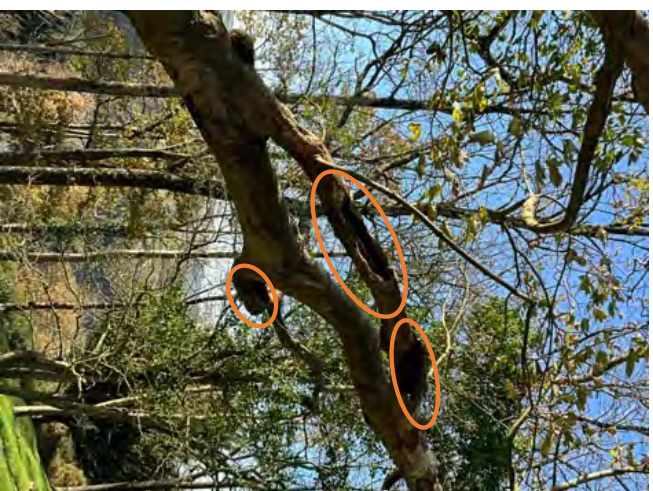
T17 – Wounds, some of which may extend

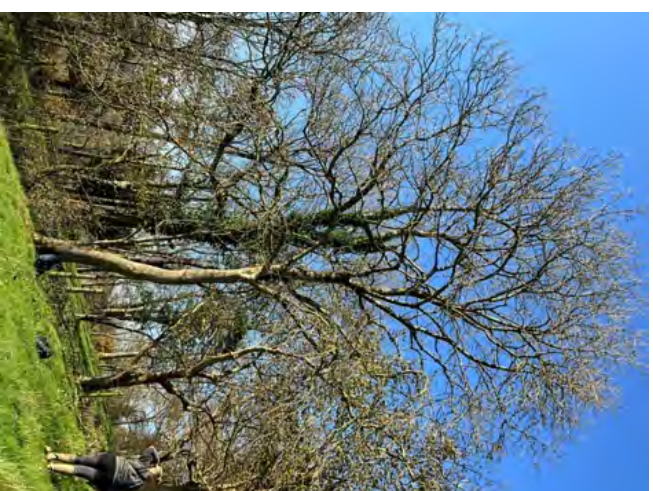
T18 – Ash (Moderate)

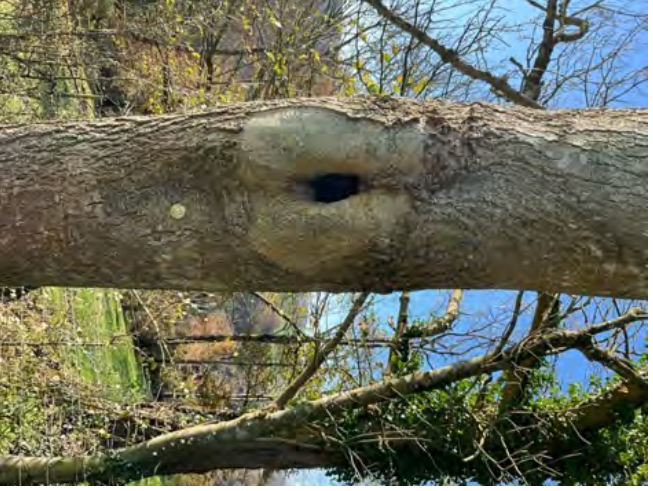
T18 – Knothole with small cavity

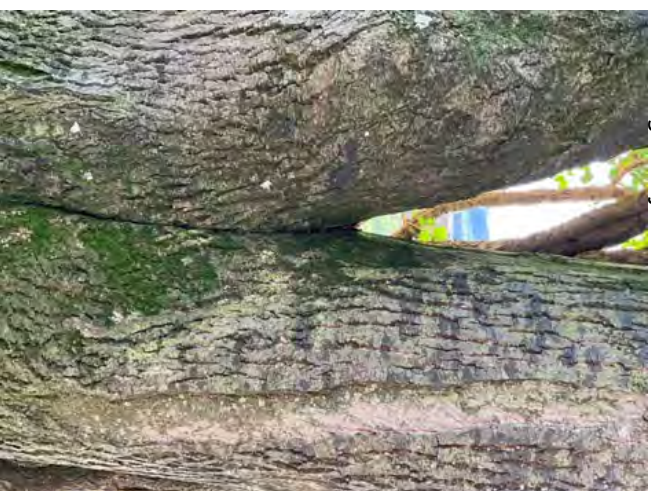
T20 – Double-leader without extending cavity

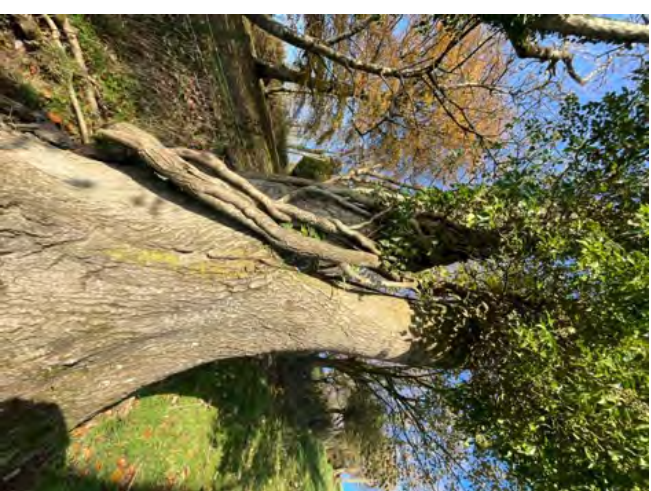
T20 – Ivy, >50 mm with some plaiting

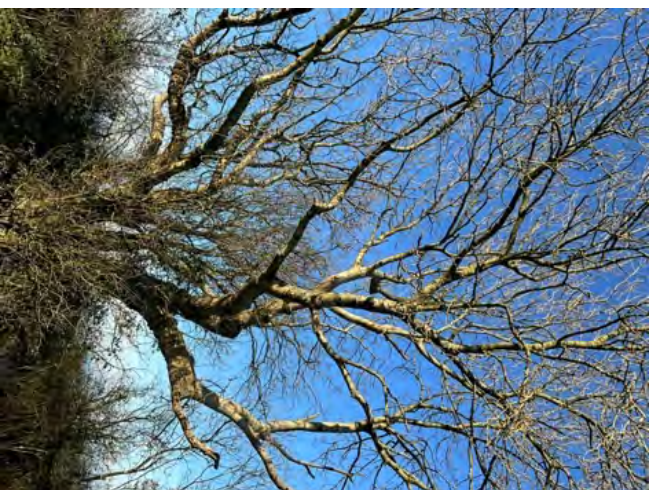
T23 – Ash (Moderate)

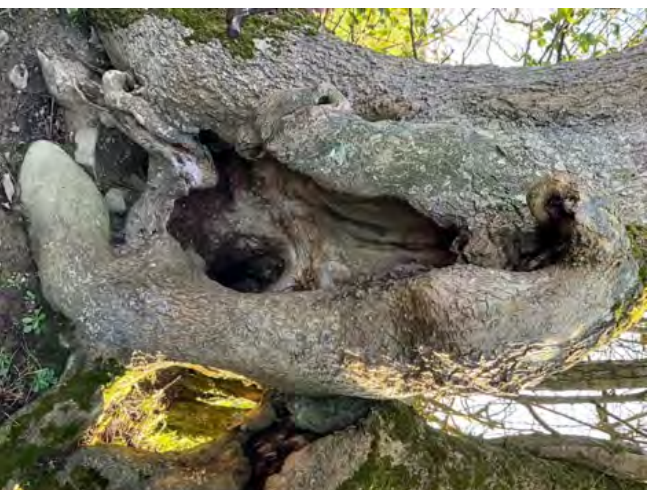
T23 – Butt-rot

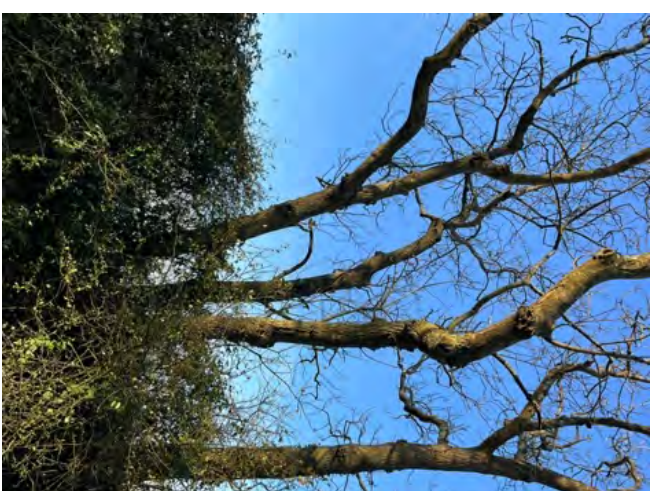
T27 – Ash (Moderate)

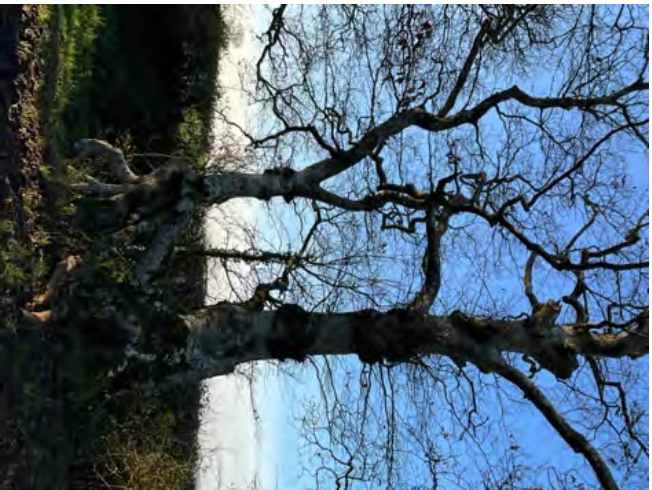
T29 – Beech (Moderate)

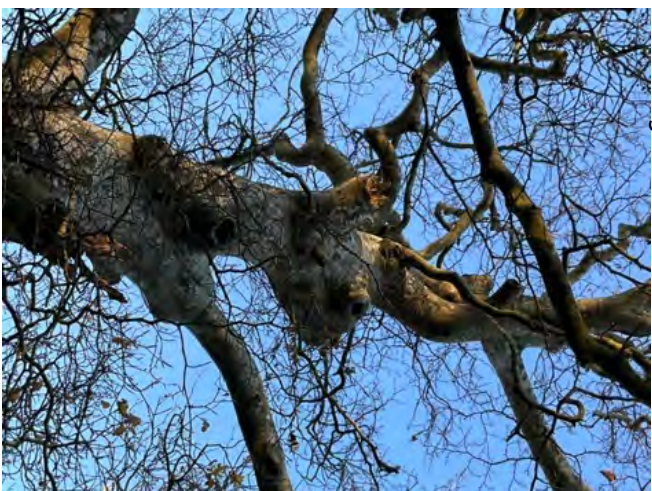
T29 – Knotholes throughout, some extending

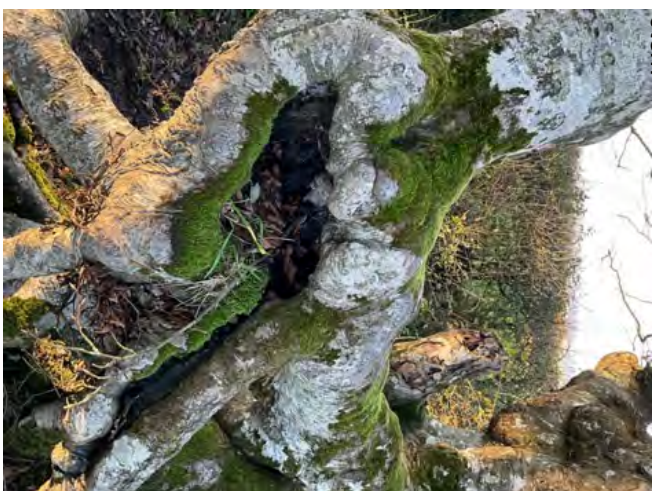
3.6 A single multi-stemmed beech (T29) had a knothole and two areas of butt-rot, one of which formed an extending cavity.

T29 – Butt-rot, extending on smaller stem
