XLINKS MOROCCO-UK POWER PROJECT

Preliminary Environmental Information Report

Volume 2, Appendix 1.11: River Condition Assessments

Report Title: XLinks North Devon – River Condition Assessments

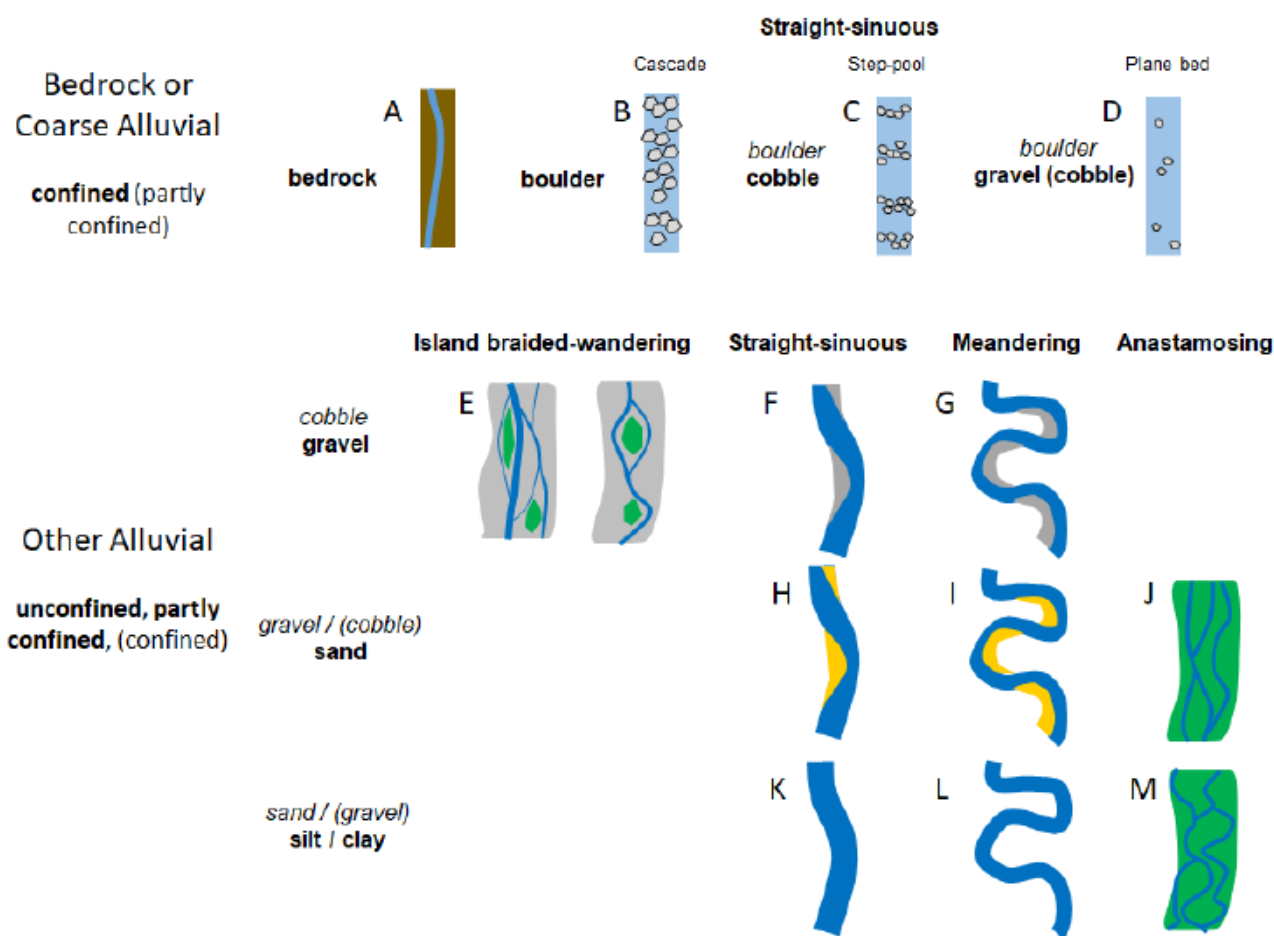
Figure 1. Thirteen near-natural river types that may be encountered in England (extracted from Gurnell *et al.*, 2020).

2.3.2 The data is entered into the Cartographer web application which automatically calculates river type from one of the thirteen types shown in **Figure 1**.

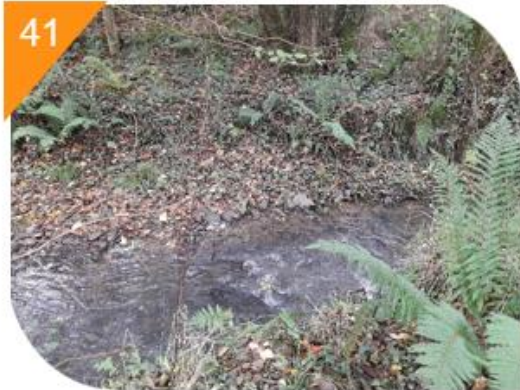
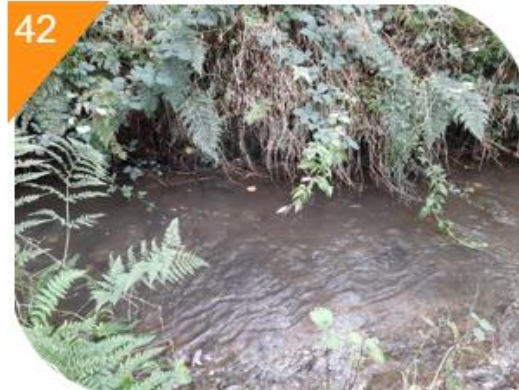
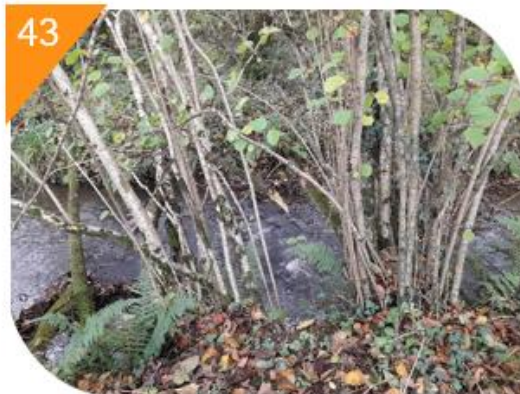
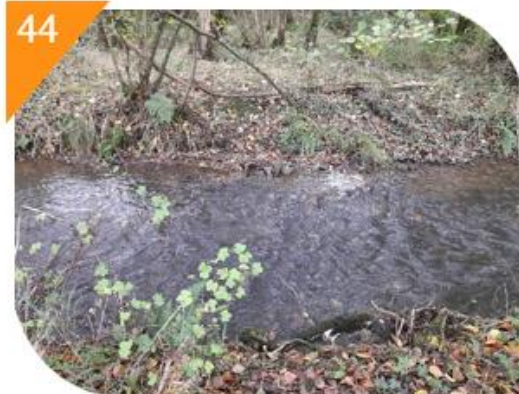
- 41 Site 6, Subreach 2, Module 1
- 42 Site 6, Subreach 2, Module 2
- 43 Site 6, Subreach 2, Module 3
- 44 Site 6, Subreach 2, Module 4

3.1.1 MoRPh5 surveys were carried out at five Sites (or 'Reaches'), each consisting of two sub-reaches, except for Site 1, which consisted of one sub-reach. The locations of each Site/Reach surveyed are displayed in **Figure 2**. Sub-reach locations for each Site are displayed in **Figures 3.1 – 3.5**. Site habitat photographs are provided in **Appendix 2**.

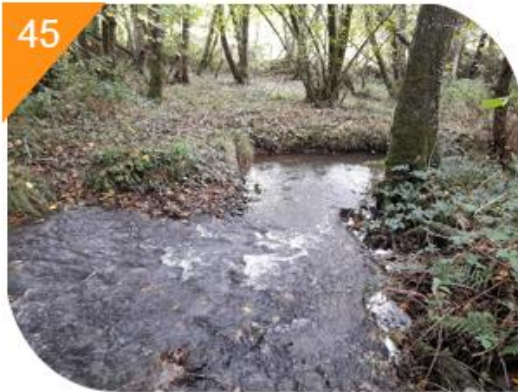
45

Site 6, Subreach 2, Module 5

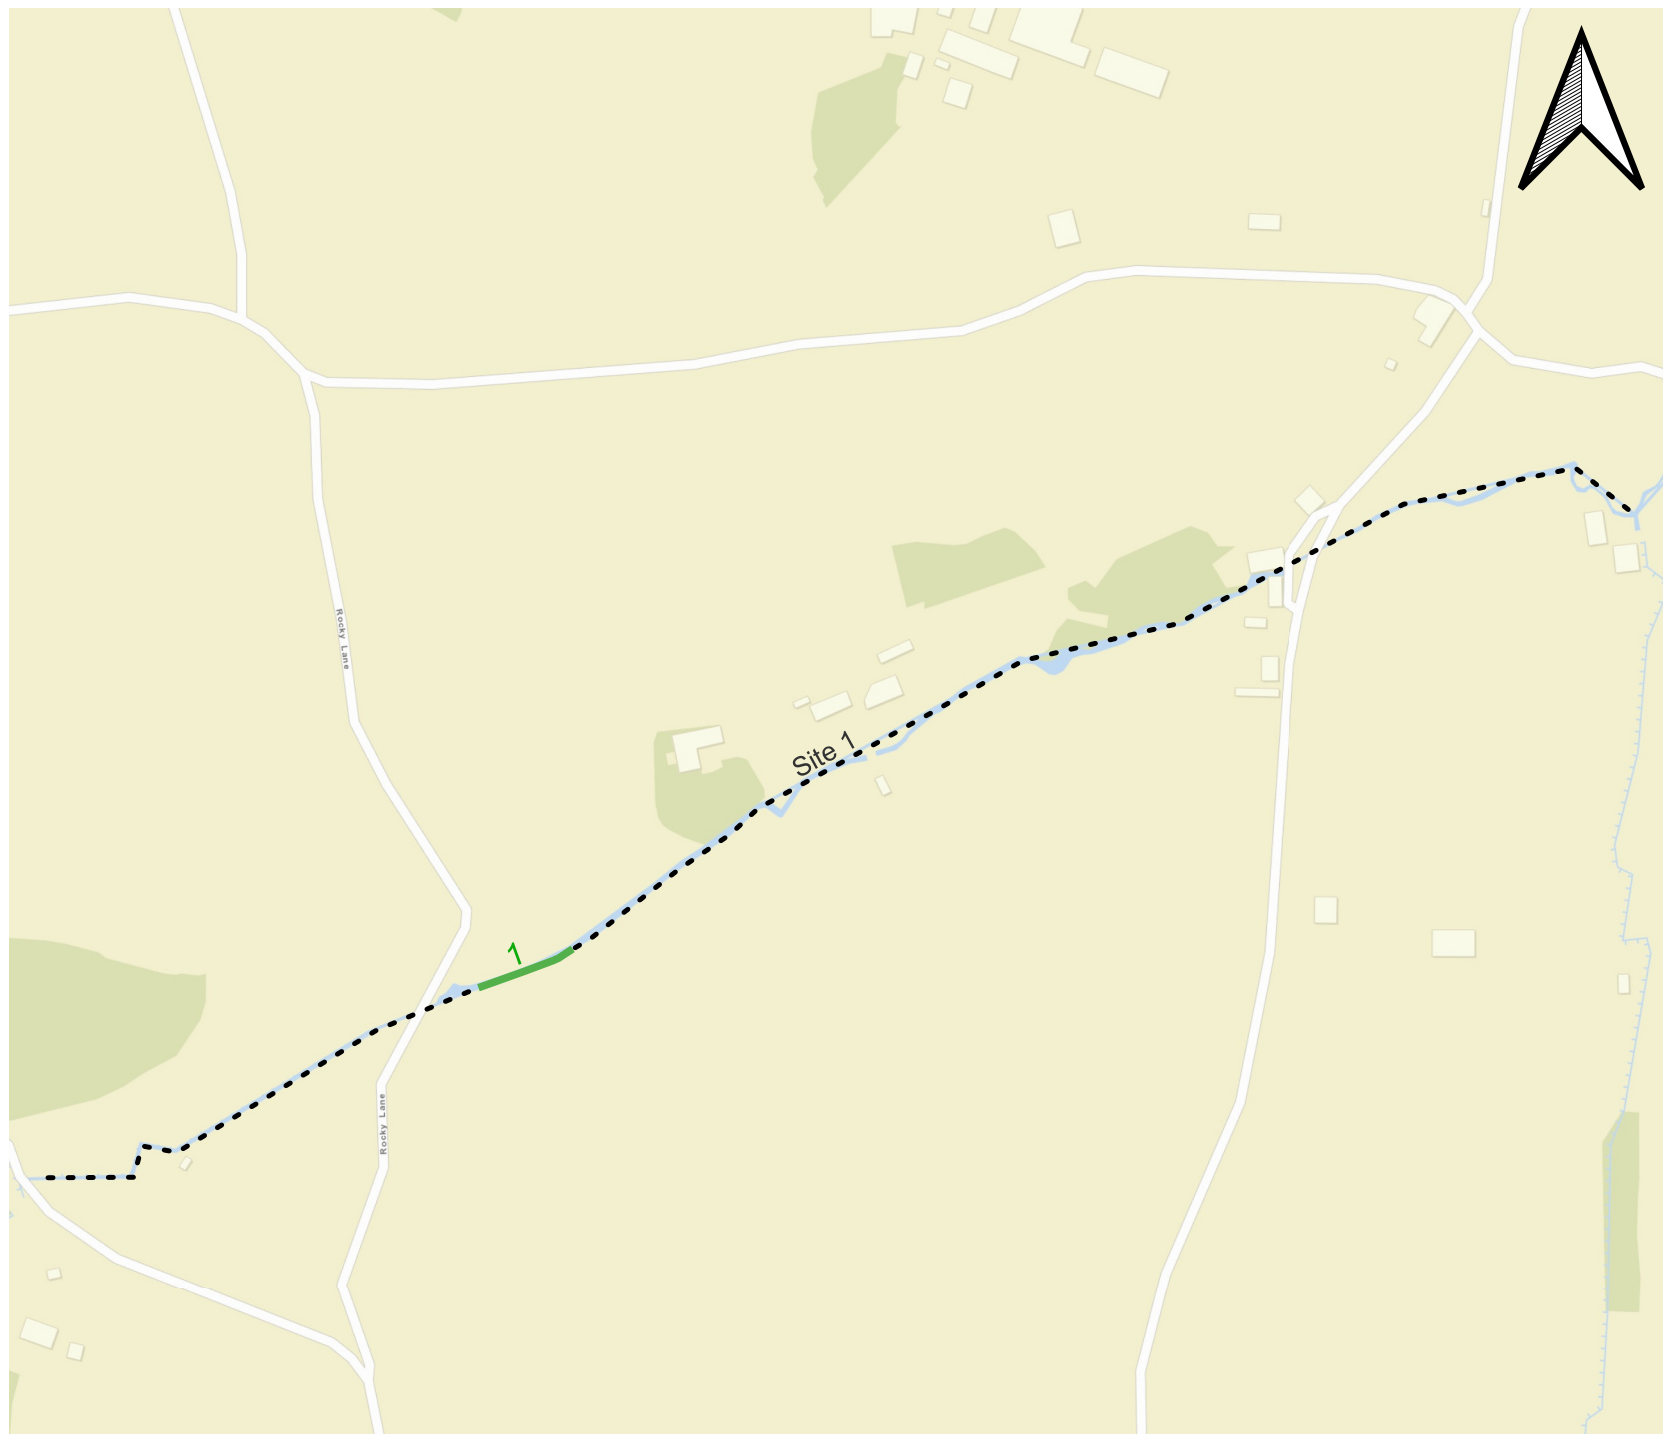
Figure 3.1
Site 1 Subreach Location

River Condition Assessment Reaches

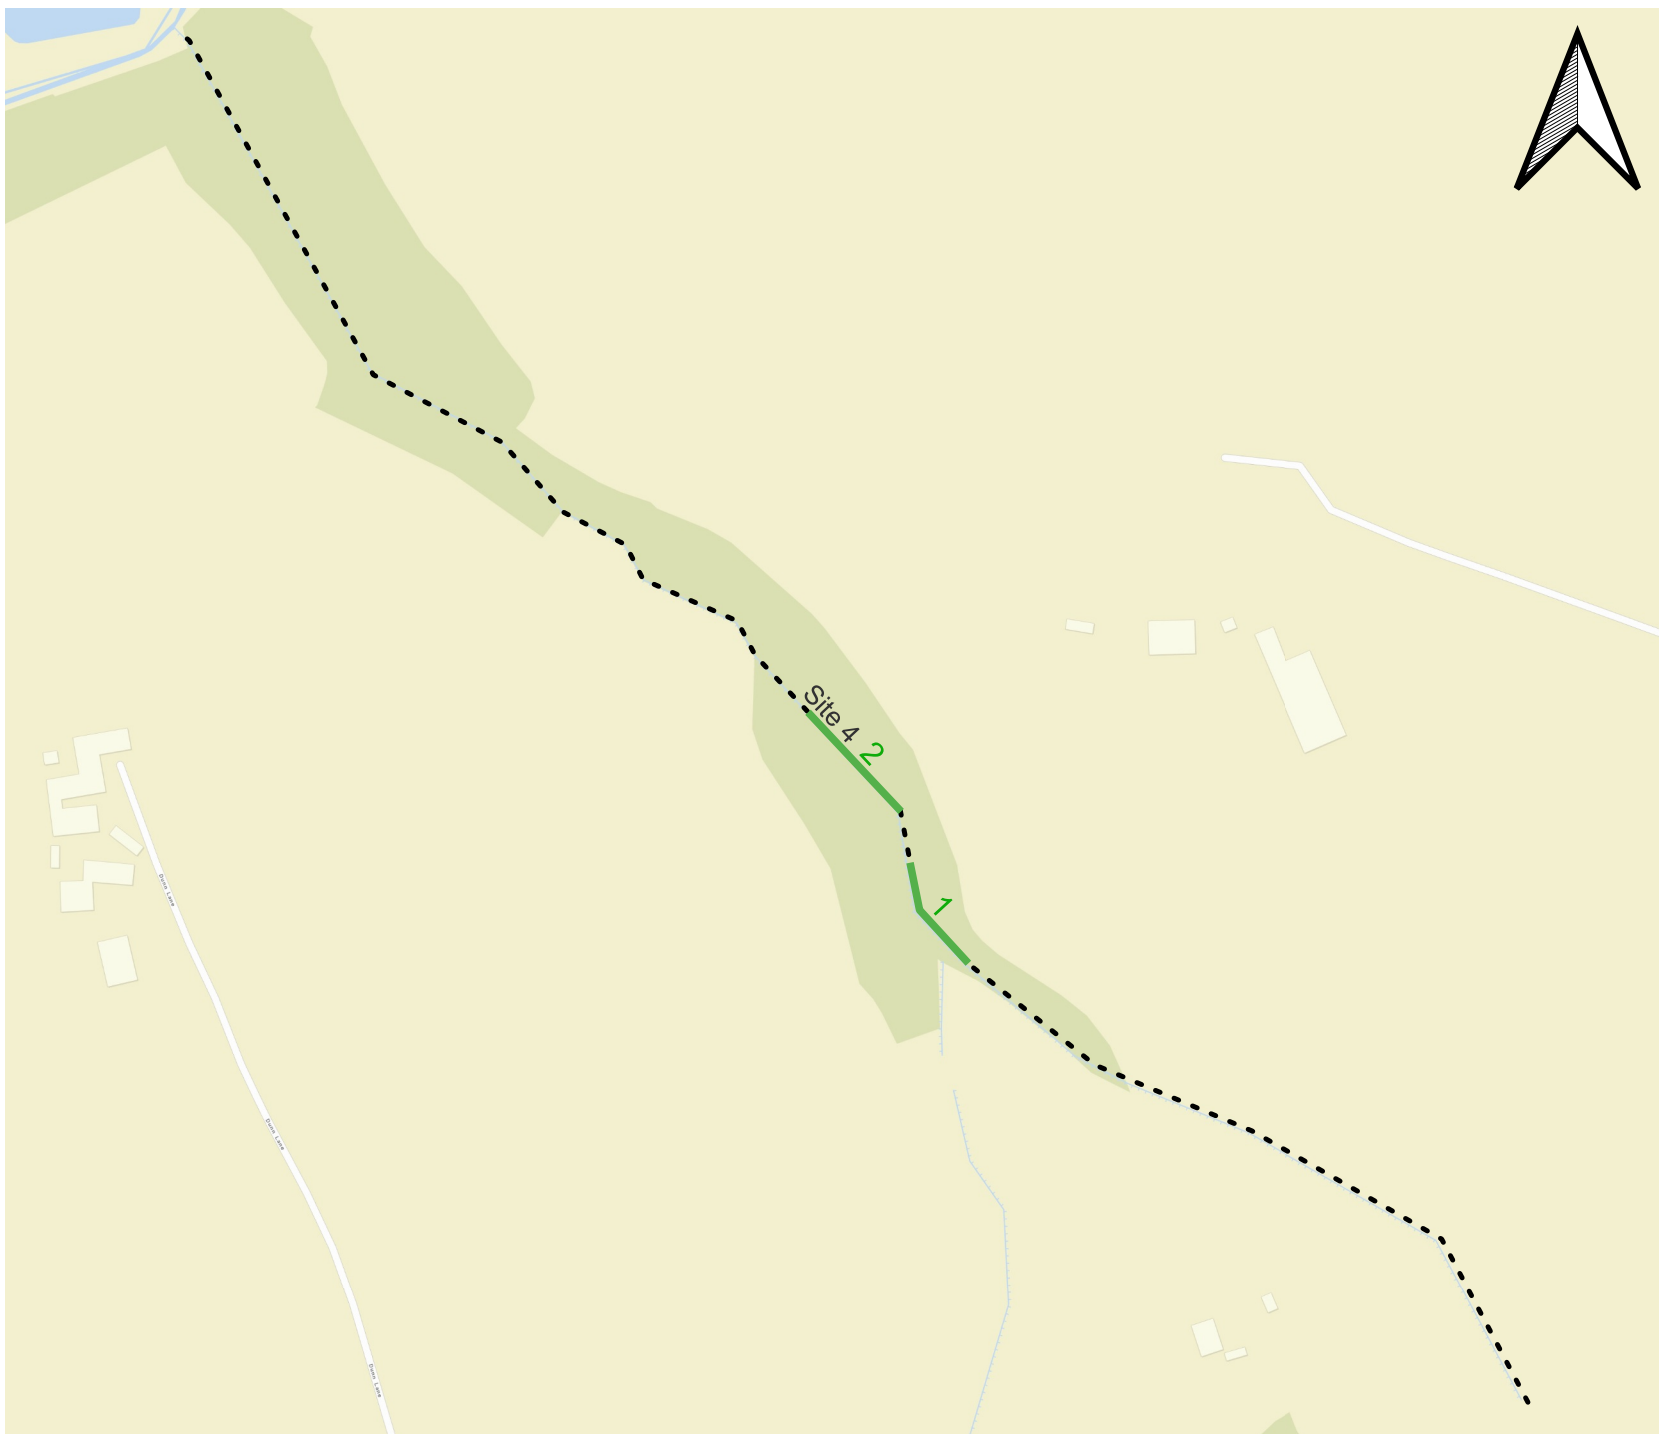
Figure 3.3
Site 4 Subreach Location

River Condition Assessment Reaches

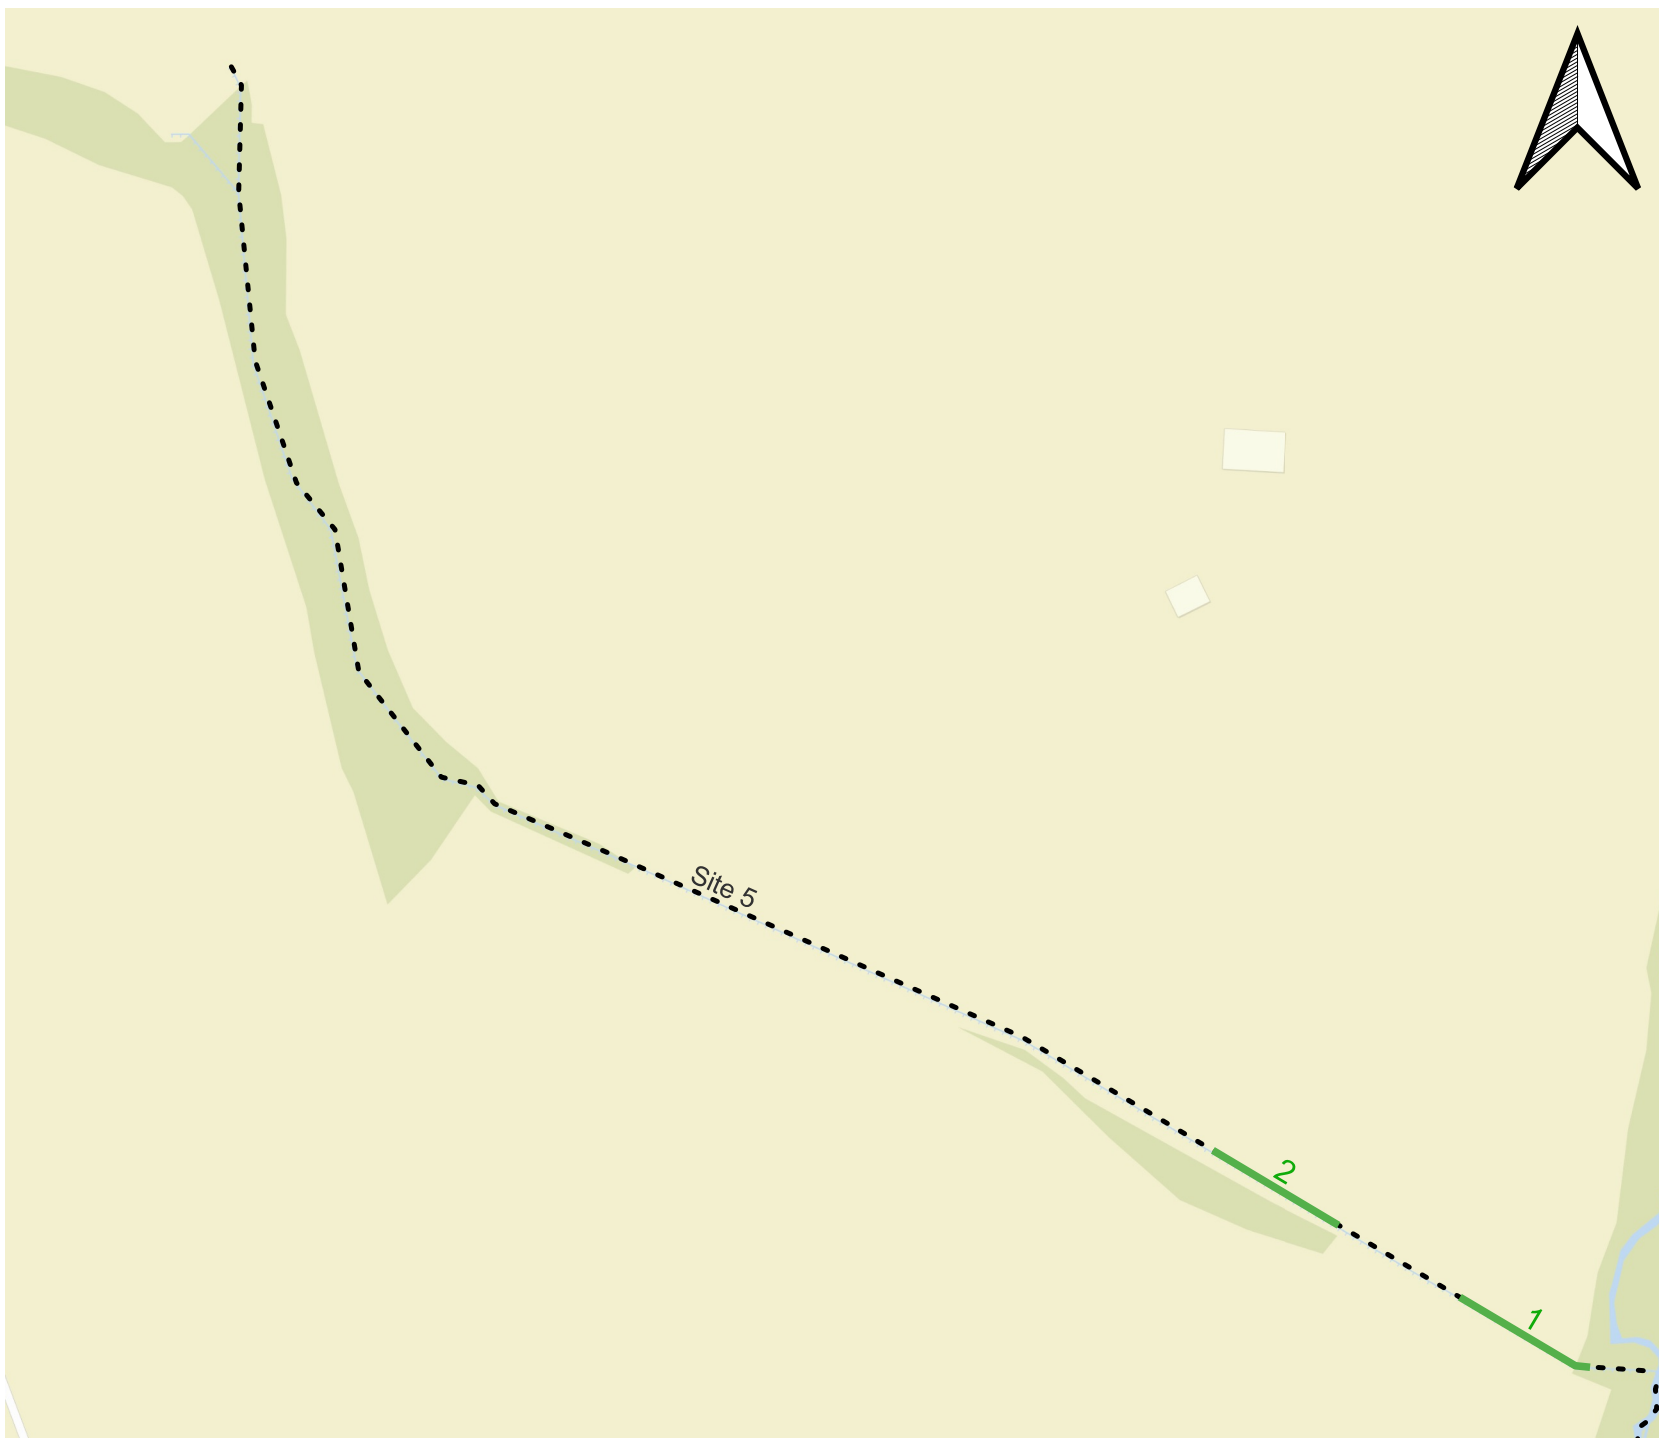
Figure 3.4
Site 5 Subreach Location

River Condition Assessment Reaches
